# Inspection Report Minerals Regulatory Program

| e Name: Smokey Joe Permit Number: M/04 | | M/047/0002 | 002 Permit | | Fees: | Paid |
| Operator Name: Interstate Brick Co. Inspection Date: | | 08/06/2013 | 3 Bond | | Amount: | \$62,400.00 |

Mine: M/047/0002 Inspected: 08/06/2013

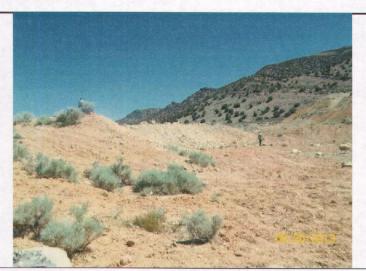
Highwall on the west side of the mine facing northwest is still too high - needs grading.

Earthwork must begin before seeding this fall. Please notify the Division when the earthwork will begin at the site so that I can come out and inspect the progress. The operator expressed interest in applying for partial bond release on the property to release the majority of the surety money less the bond money left for vegetation.

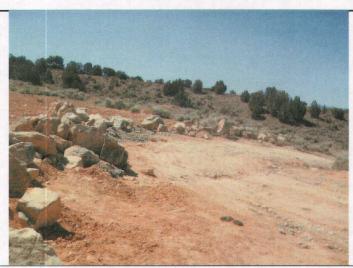
View of the boulders that have been placed separating the mine from the road. The boulders for the most part block access but there are still areas where access is possible for off road vehicles.

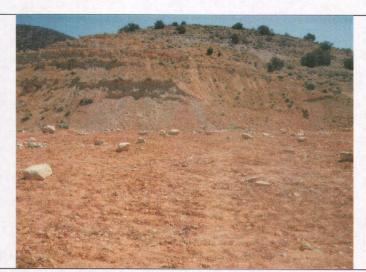
Highwall view: ATV tracks have been removed since May 2013 inspection.

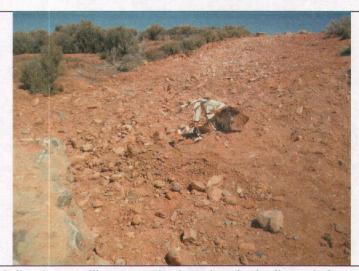
Trash and shell casing are still present at the site and need to be disposed of.
